Sheet Metal Forming for the Construction of a Standardized Steelpan Drum

NORTHERN ILLINOIS UNIVERSITY

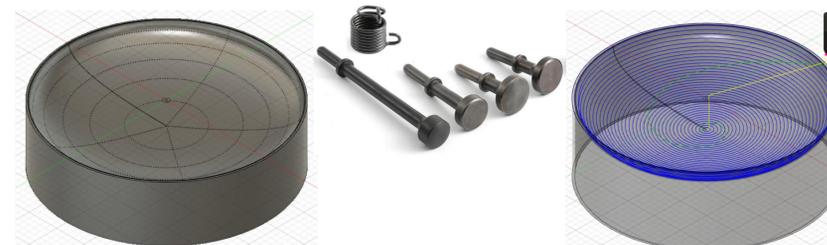
The steelpan drum was designed through Fusion360, in which the G-code was generated through the manufacturing application. The hammerheads used has a rubber tip added to reduce ripples and tears on the surface. The addition of the rubber would also make a smoother surface since there would be a buffer between the two surfaces.
